BPIX Module Testing Status - Week 20

21st May 2007

Module Testing Report of Week 20:

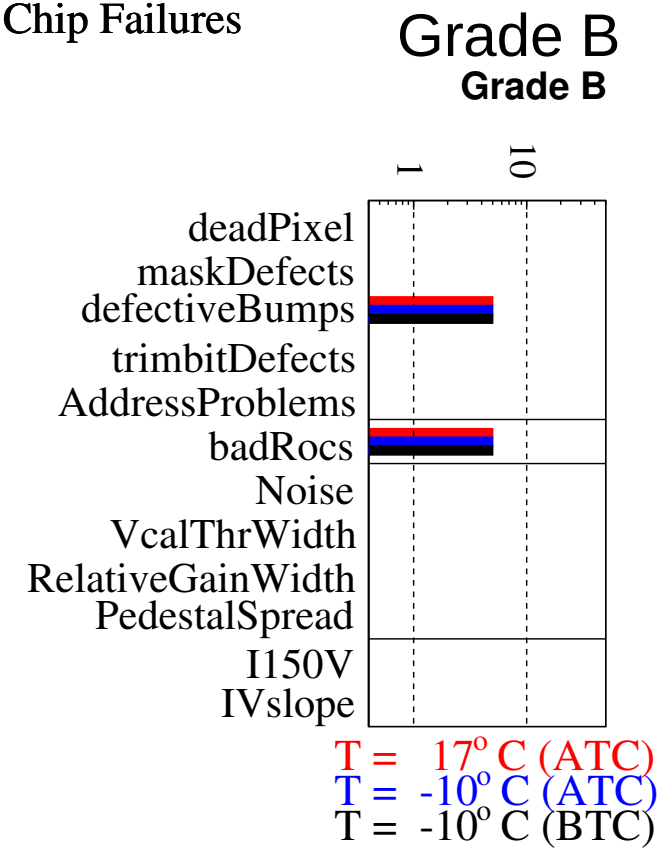
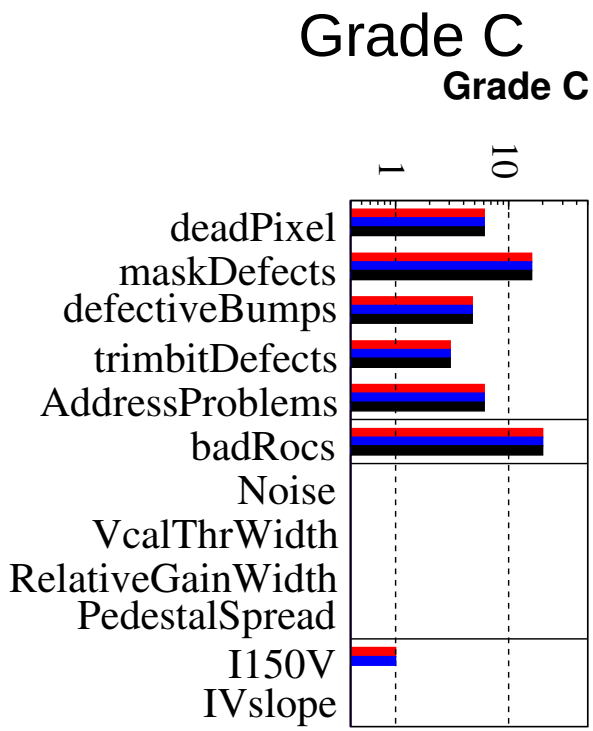
Chip Failures

← Pixel defects

← Chip performance

← Module IV

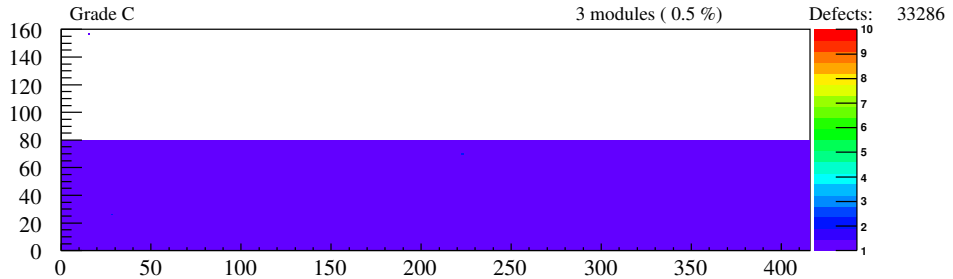
Grade C
(3 modules)

Defective pixel $T = 17^{o}C$ (ATC)

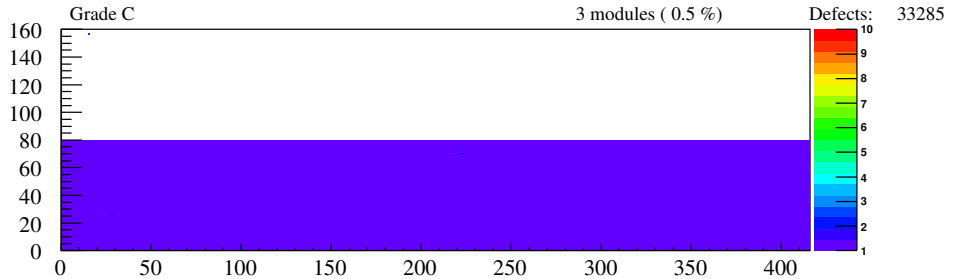
Grade C
(3 modules)

Defective pixel $T = -10^{o}C$ (ATC)

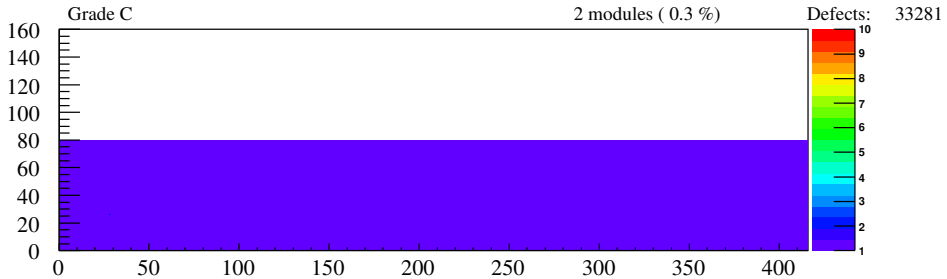
Grade C
(2 modules)

Defective pixel $T = -10^oC$ (BTC)

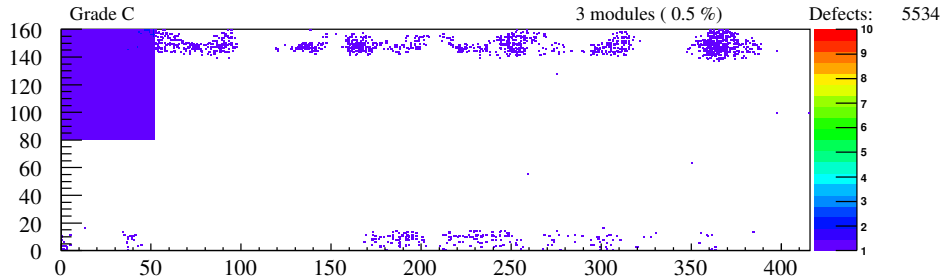
Grade C
(3 modules)

Defective bump-bonds $T = 17^oC$ (ATC)

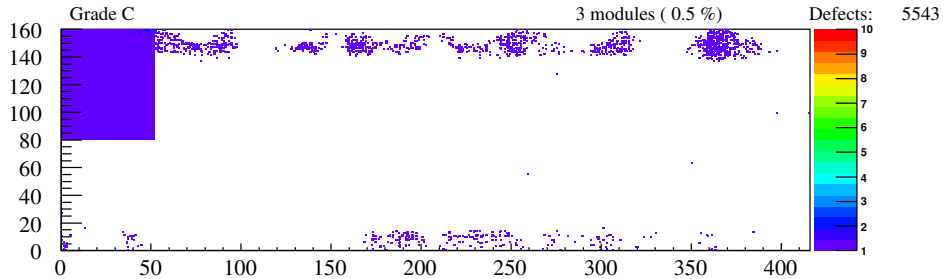
Grade C
(3 modules)

Defective bump-bonds $T = -10^{o}C$ (ATC)

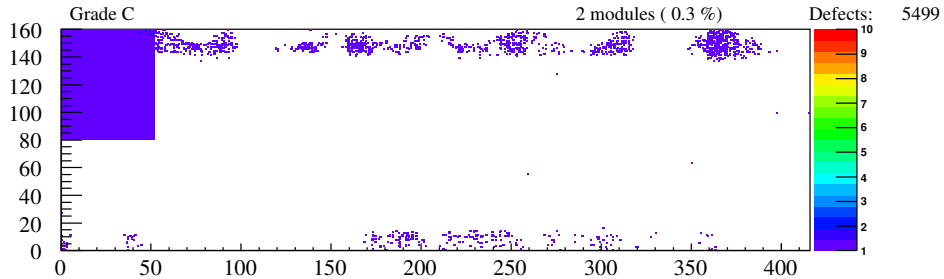
Grade C
(2 modules)

Defective bump-bonds $T = -10^{o}C$ (BTC)
